## PIC24FJ128GA204 Family Silicon Errata and Data Sheet Clarification

The PIC24FJ128GA204 family devices that you have received conform functionally to the current Device Data Sheet (DS30010038C), except for the anomalies described in this document.

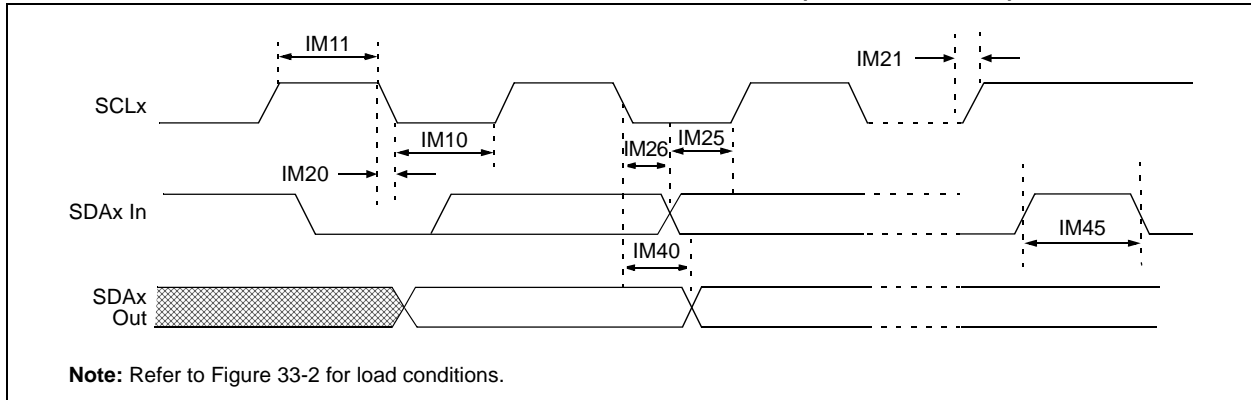
**FIGURE 32-5: I<sup>2</sup>C BUS DATA TIMING CHARACTERISTICS (MASTER MODE)**

Figure 32-5 and Figure 32-7 are modified as shown in the figures below.
